AGARD CONFERENCE PROCEEDINGS 550

## Composite Repair of Military Aircraft Structures

*Papers presented at the 79th Meeting of the AGARD Structures and Materials Panel, held in Seville, Spain 3-5 October 1994*

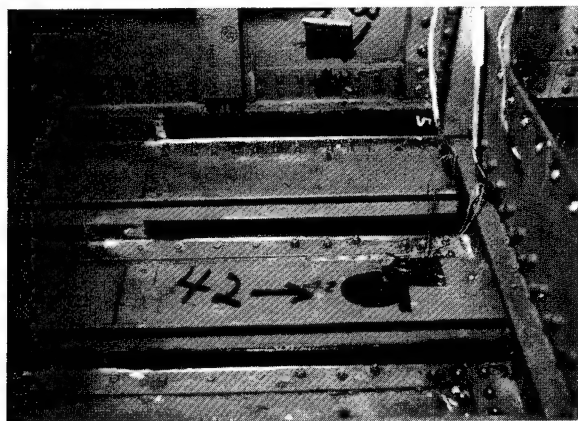
Figure 13. Boron/Epoxy Strip Modification - Inboard of BL 61

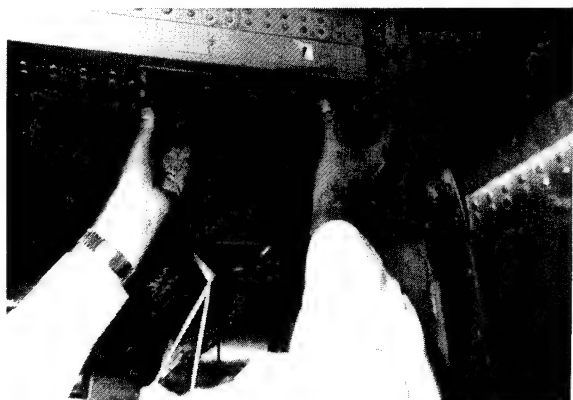
**Figure 15. Graphite/Epoxy Patch During Prefit**

After the strain survey, cyclic testing was resumed and the unrepaired cracks on the specimen right side regularly checked. Figure 14 shows a comparison of these cracks at 26,000 and 34,000 cyclic test hours. At 34,000 cyclic test hours (or 58,000 flight hours at BL 61), these cracks were approaching 3 inches and the decision was made to apply the repair. Figure 15 is a photograph of the graphite/epoxy repair patch being prefitted prior to bonding.

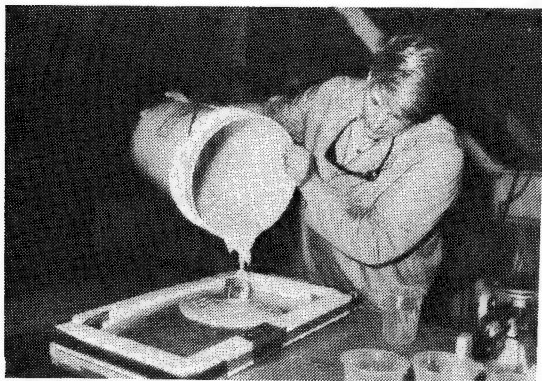
Figure 8. CARE MOLD Cermaic Male Tool for Patch Fabrication Process

blocks were pushed into splash mold edges to form a dam to contain the CARE MOLD slurry. Pouring the CARE MOLD tool slurry into the female splash is shown in **Figure 8**. The completed male tool was cured at 385°C (725°F) for 30 minutes in an oven.
